11. TITLE (Include Security Classification) Yatesville Lake, Big Sandy River Basin, Blaine Creek, KY Foundation Report, Construction of Dam and Appurtenant Works, Phase II Vol. 2

# YATESVILLE LAKE

## FOUNDATION REPORT VOLUME II

CONSTRUCTION OF DAM AND APPURTENANT WORKS, PHASE II

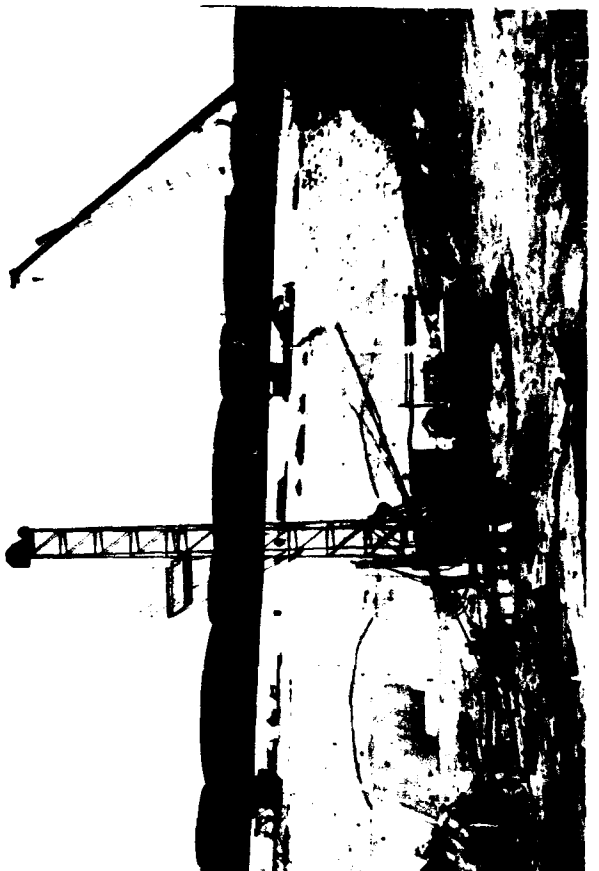
23 Sep 1987, Exploratory core drilling at valley bottom of dam, Longyear 44 drill.

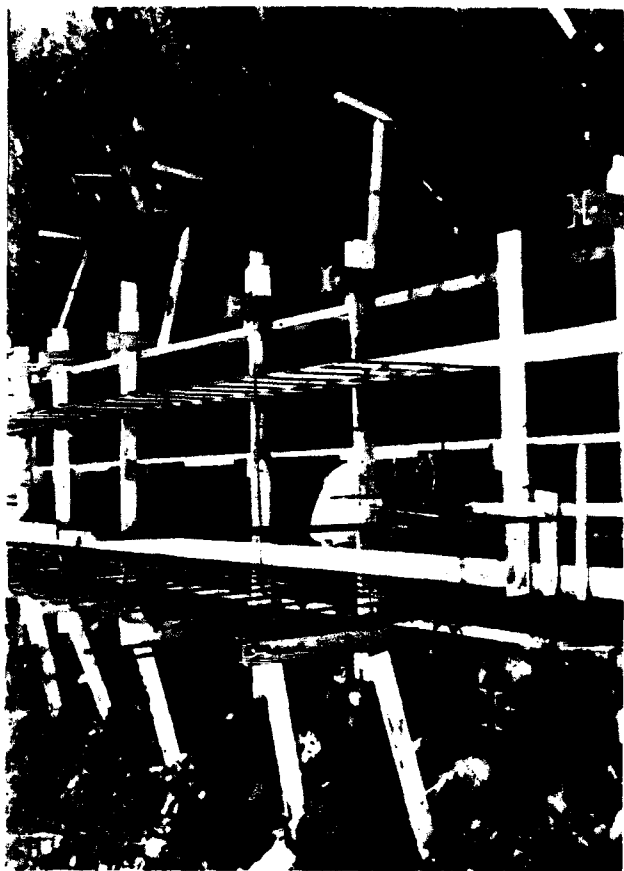
11 Jun 1987 - Spillway sill

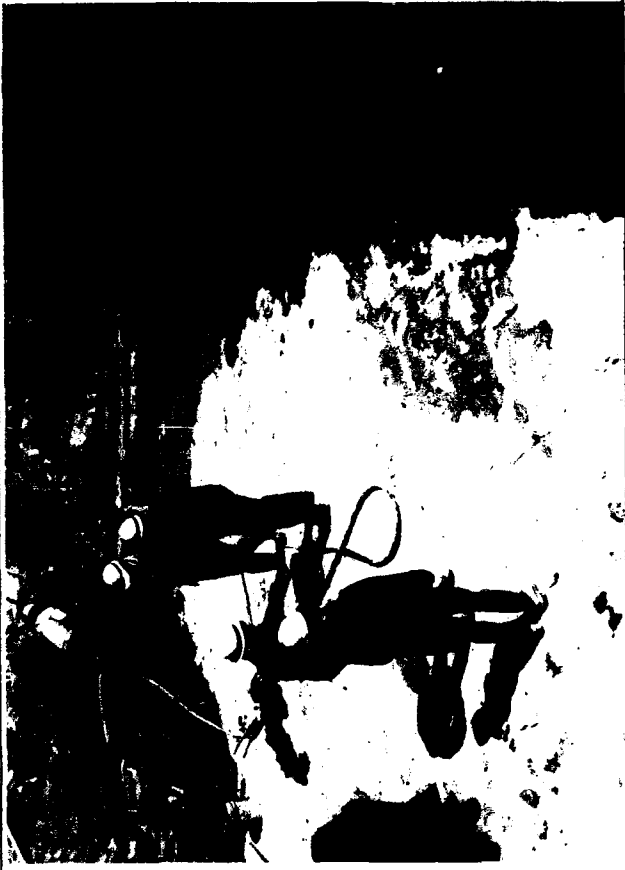
18 Mar 1988 - Area for dental concrete, 6cy, to treat broken zone, sta. 5+60-5+80, 24'-50' U/S.

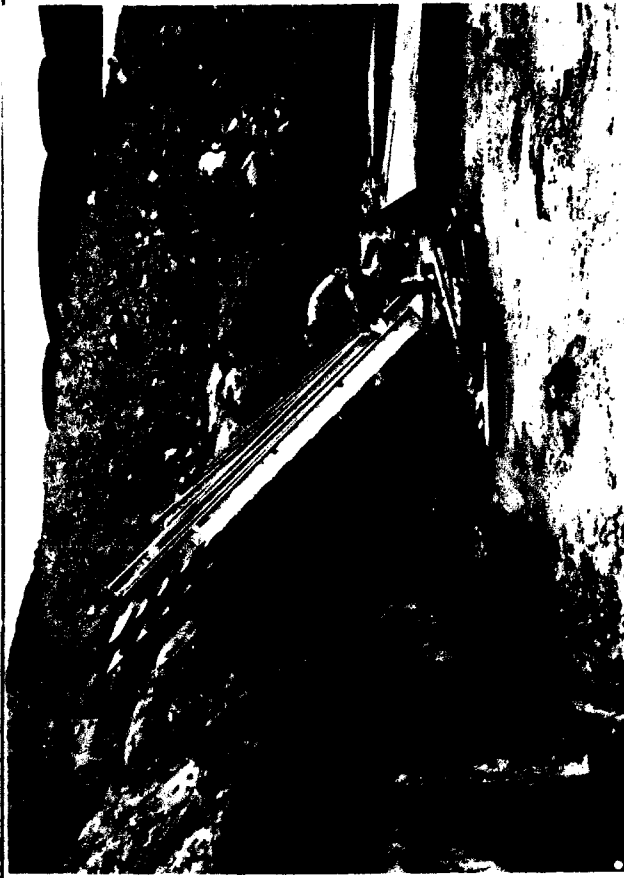
15 Apr 1988 - Area for dental concrete, 3cy, to treat a thin shale seam, sta. 4+37-4+71, 2'-30' U/S.
